# Manhole Inspection Summary

Manhole # S19Y\_\_001MH

Insp Date: **6/19/08 10:19 AM**

**Location** Address: **2401 washington bd**

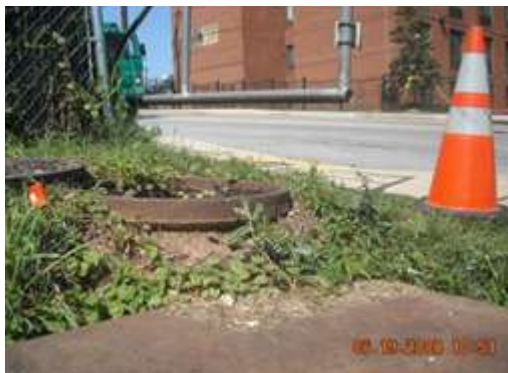
Misc

frame above grade

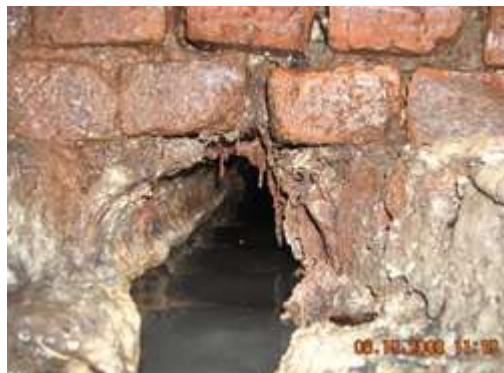
Defect

Condition: ☐ Sound ☐ Cracked ☐ Root Intrusion ☒ **Deteriorated** ☐ Leaks ☐ Debris

bench & channel deteriorated

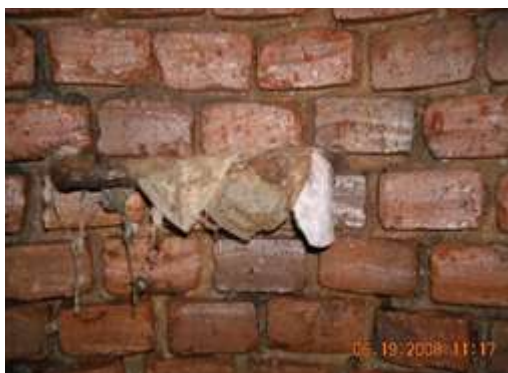
Defect 1

Count: **6** Missing: **0** ☒ **Corroded**

☒ **Evidence Of Surcharge** Depth: **5** (ft.) ☐ Active Surcharge Present

evidence of surcharge; steps corroded

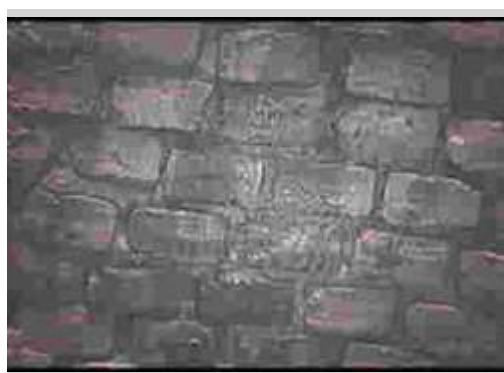
Defect 3

Infiltration: ☐ None ☐ Joint ☒ **Cracks** ☐ Mortar ☐ Roots ☐ Wall

infiltration @ barrel wall

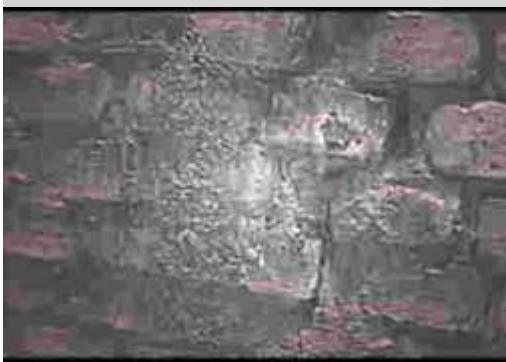
### Defect 2

Condition: ☐ Sound ☒ **Cracked** ☐ Root Intrusion ☐ Loose Brick ☐ Deteriorated

cracked barrel; mortar separation

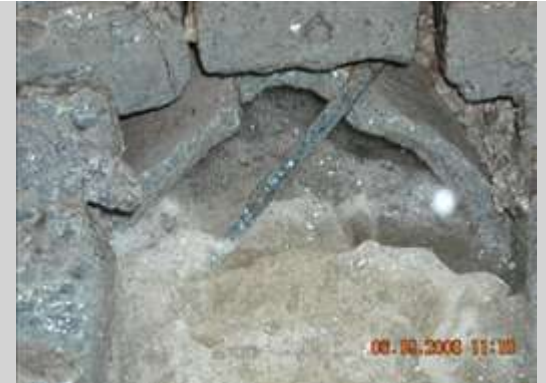
12 O'Clock Outflow

Pipe Height: **8.4** (in.) Rod and Bar (Angled)  
Pipe Material: **Clay** ☐ Pipe Lined  
Invert Depth: **11.03** (ft.) Flow Characteristics: **Turbulent**  
Deposits: ☒ None ☐ Mud ☐ Gravy ☐ Debris ☐ Grease  
Silt Depth: **0** (in.) Deposits Extent:  
Infiltration: **None** Pipe Seal Cond: **Broken**

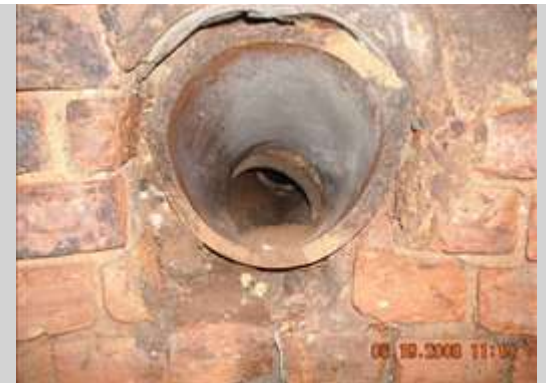
6 O'Clock Inflow

Pipe Height: **8.4** (in.) Rod and Bar (Angled)  
Pipe Material: **Clay** ☐ Pipe Lined  
Invert Depth: **5.26** (ft.) Flow Characteristics: **Turbulent**  
Deposits: ☒ None ☐ Mud ☐ Gravy ☐ Debris ☐ Grease  
Silt Depth: **0** (in.) Deposits Extent:  
Infiltration: **None** Pipe Seal Cond: **Broken**

Drop: **Outside** Rod and Bar  
Angled: **Yes** Reading: **9.60** (ft.)  
Inv Depth: **10.60** (ft.)

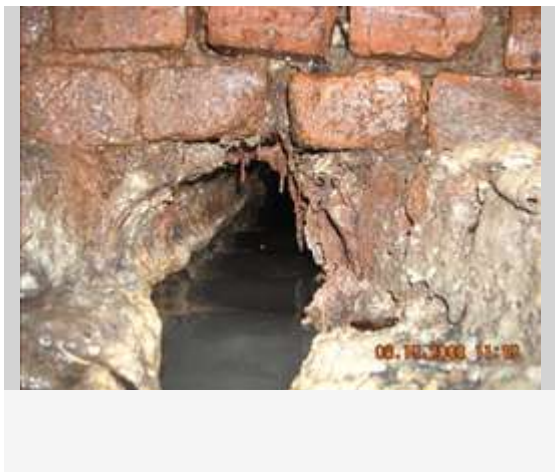
9 O'Clock Inflow

Pipe Height: **8.4** (in.) Rod and Bar (Angled)  
Pipe Material: **Clay** ☐ Pipe Lined  
Invert Depth: **10.95** (ft.) Flow Characteristics: **Slow**  
Deposits: ☐ None ☐ Mud ☒ **Sludge** ☐ Debris ☒ **Grease**  
Silt Depth: **3** (in.) Deposits Extent: **Medium**  
Infiltration: **None** Pipe Seal Cond: **Broken**
